Ash Vale Bat House

Ash Vale, Surrey, England

Network Rail

BIG Biodiversity Challenge Award category: Small Scale Permanent

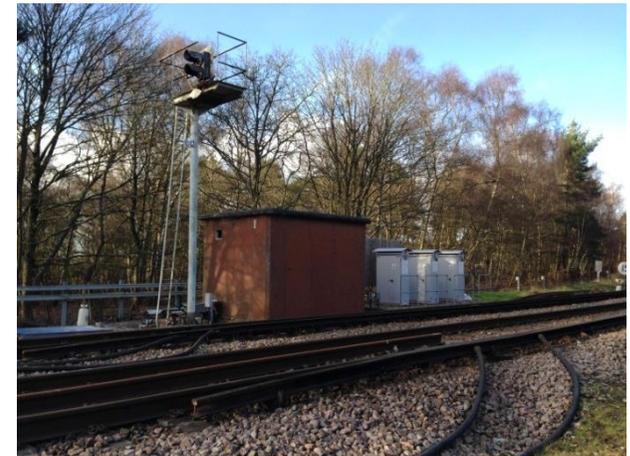
View of retained relay room next to railway. The signal box was located the other side of the signal from the relay room.

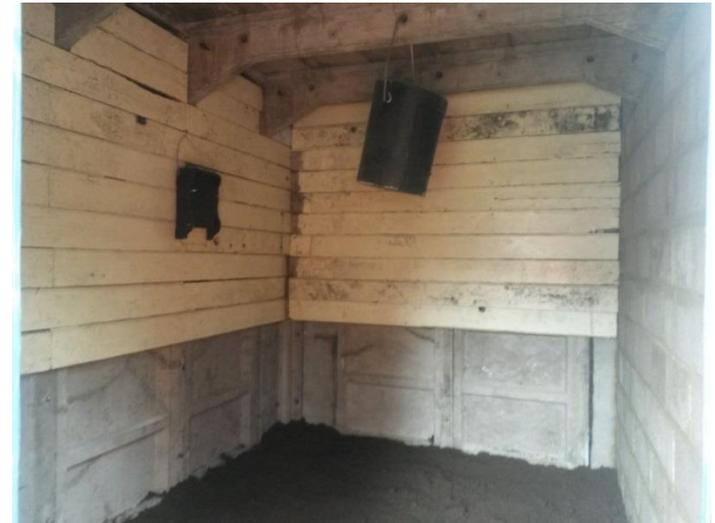
View into the enhanced relay room from the main door. To the right is the breeze block wall with gaps for bats to roost in. Front and to the left is the wooden panelling with space underneath to enable monitoring. Two bat boxes included in the building, one suspended from the concrete beam and another mounted on the wall. Soil on the floor improves temperature and humidity.

Installations included new bat access bricks, internal wooden panelling for bats to roost behind (a gap has been left underneath to enable ongoing monitoring checks), breeze block wall with gaps left for bats to roost in. A hibernation bat box was suspended from the ceiling and soil was laid on the floor to improve the humidity and temperature control. A new door was installed with signage restricting access to the building. Materials reused on site were the wooden planks and breeze blocks.
