Coldharbour River wall repair ecological enhancement
Isle of dogs - London
Environment Agency

BIG Biodiversity Project of the year: Small Scale Enhancement

Project overview

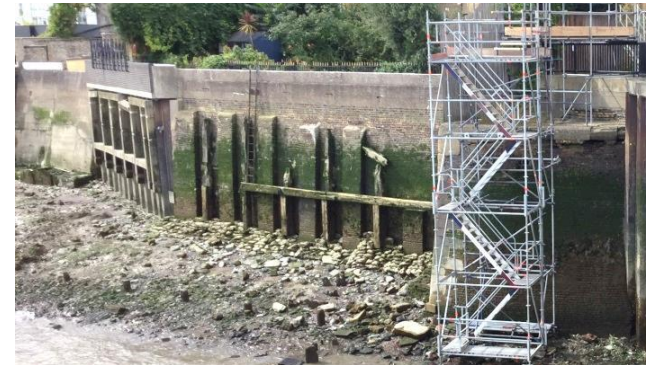
1 Coldharbour Lane wall with temporary repair

The river wall at Isle House, 1 Coldharbour, London E14, had been undermined and a temporary solution of concrete sandbags had been installed to prevent further erosion. This temporary solution was removed and toe beam was cast in place with Kyowa bags protecting the foreshore from scour and new fenders installed.

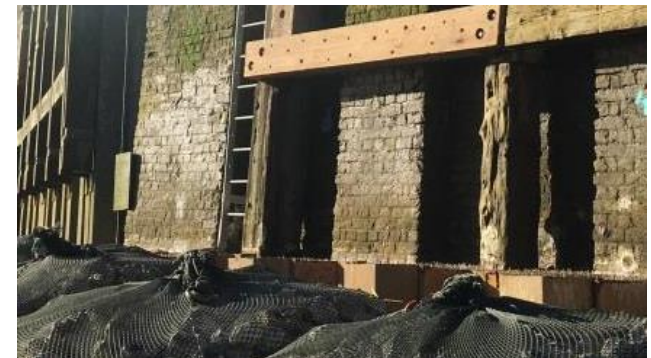
Above: 1 Coldharbour lane timber fenders and Kyowa bags installed, predrilled holes visible on the fenders.

The wall remediation works were designed to improve the intertidal microhabitat through the use of recycled timber fenders predrilled to provide access for marine life. The Kyowa filter units (gabion bags) were also selected as they provide shelter for marine flora and fauna, between the bags and in the voids between the aggregate.

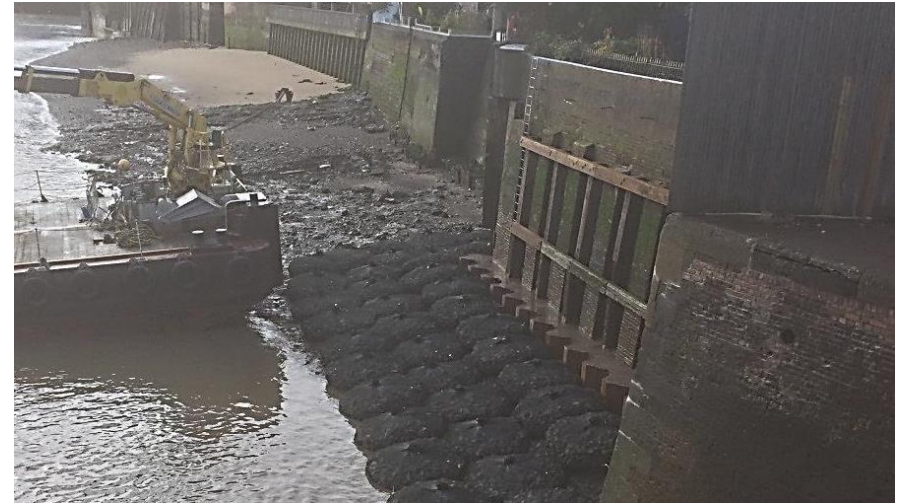
1 Coldharbour wall repair completed

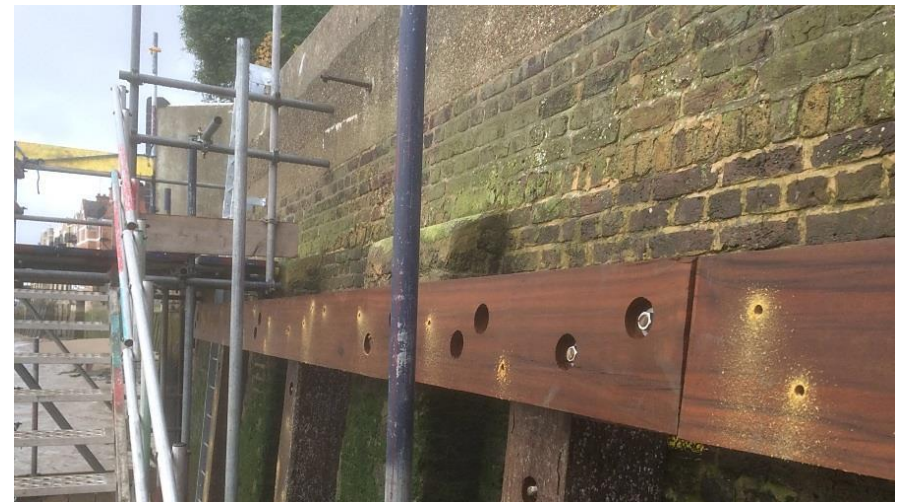
Close up of holes provided in the greenheart

The timber that was used for the fenders is recycled green heart from works replacing piers. The oversized timber was cut to size, giving the new appearance, and holes were drilled along the length and on all four sides of the timbers. These holes have been chosen to accommodate for marine invertebrates. The reduced lifespan of the timber fenders, due to the holes, has been considered in the design and as the fenders are only serving an aesthetic purpose.

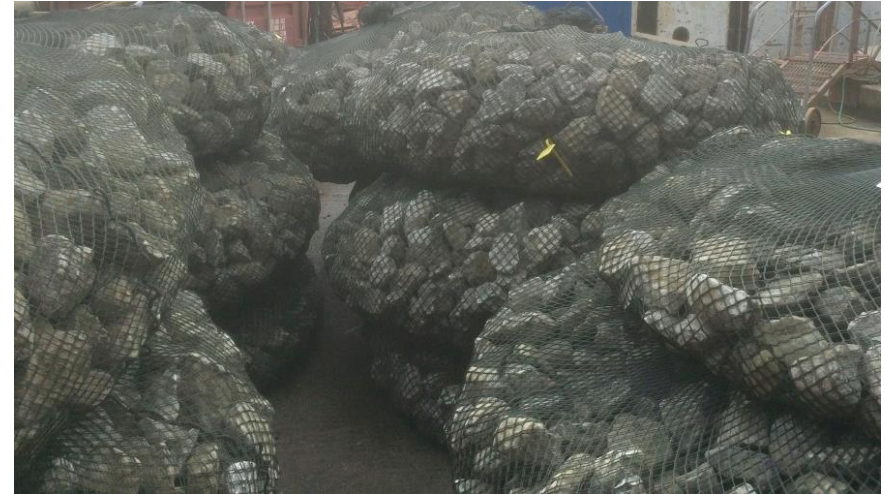
Close up on the Kyowa bags

The Kyowa bags had previously used on TEAM2100 as part of a similar wall repair and have proved an excellent addition to the environment providing shelter and larger intertidal areas. The bags have a lifespan of 30 years and will provide scour protection during this time. At the end of the lifespan the bags can be removed, the aggregate recycled into new bags and replaced.

There has already been marine growth noted on the Kyowa bags after their installation in November of 2017. There is also potential for further enhancements by using recycled aggregates in the Kyowa bags and this has been incorporated into the lessons learnt.

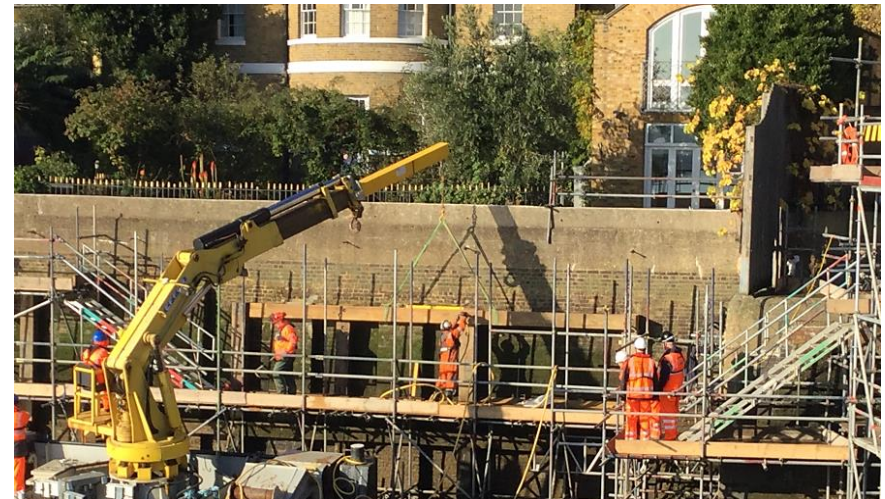
Installation of the timber fenders:
